Product Quality Notice

Notice number: **PQN-2**

Affected product: **GB142 Gas Condensing Boiler**

Subject: **Quality Improvements on Spare Parts**

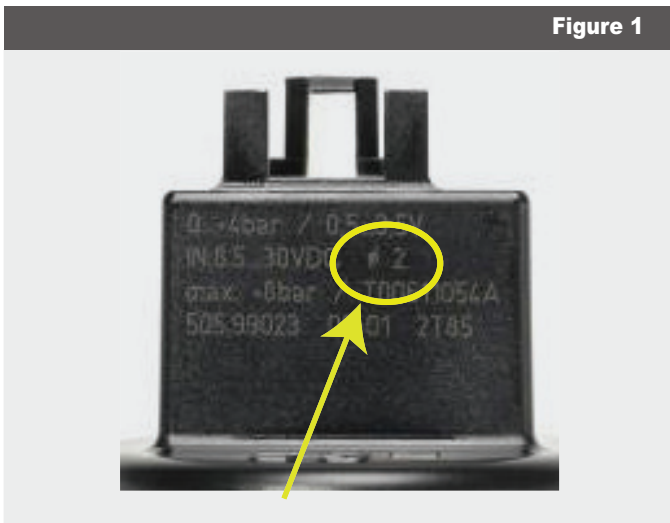
Figure 1

- **Problem description:**
Due to dirt accumulating in the measuring hole of pressure sensor, the failures "2L-266/328" and "CO -288" can occur on the display.
- **Product Improvement:**
Diameter of measuring hole increased from 0.9mm to 2.0mm. The new pressure sensor can be recognized by the ø2 sign on the spare part (see Fig. 1).

- **Effective Date:**
New Sensor included with boiler starting June 1st 2009.
New Sensor available as a spare part starting June 1st 2009.

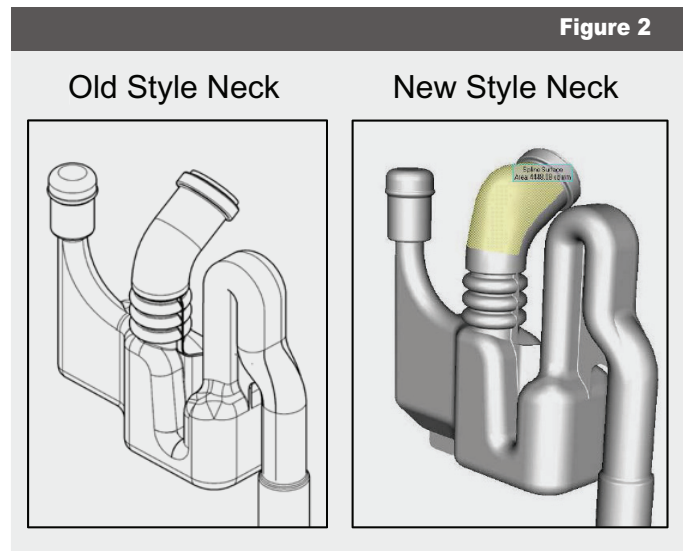
Figure 2

- **Problem description:**
If condensate traps dry out the plastic may crack at the neck. Difficulty removing the trap for maintenance may also unintentionally lead to stress cracking.
- **Product Improvement:**
Material changed to Bralen RB 03-23 known for high environmental stress cracking resistance. Neck design changed to allow ease of removal and prevent unintentional cracking through handling (See Fig. 2).

- **Effective Date:**
Material change – June 2007
Neck Design change – April 2008
- **Field Inventory Action:**
Any condensate traps currently in field inventory with an FD < 7151 (see Fig. 3, how to read FD) may be returned for a replacement. Please call customer service to obtain an RMA. Photo identification of the FD number will be required for credit.
